# AGUA PARA LA VIDA - NICARAGUA RÍO BLANCO

## DRINKING WATER AND SANITATION LOS PINARES, TELPANECA, NICARAGUA - FINAL REPORT -

Project Start: March 17, 2010  
Project Completion: October 7, 2010

**Río Blanco, January 3, 2011**

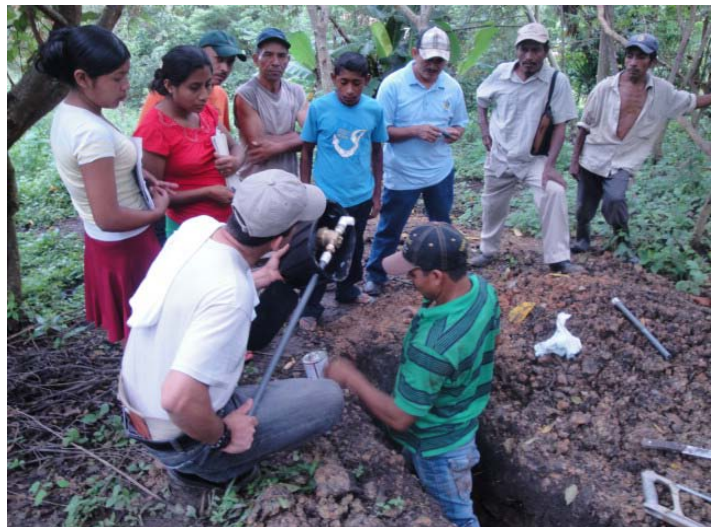
**Practical training 'Installation of meters'**  
**APLV Technical Project Manager**

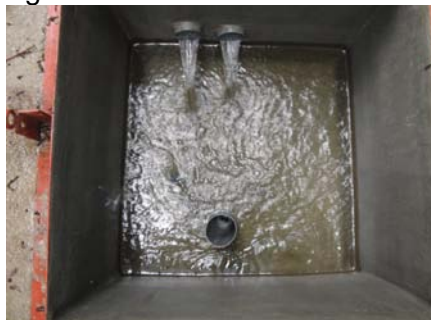
In this system, we built two closed spring catchments that produce sufficient flow to the demand of the population projected to 15 years. Both are east of the community with a boundary on a nature reserve.

**Collection box at the spring**

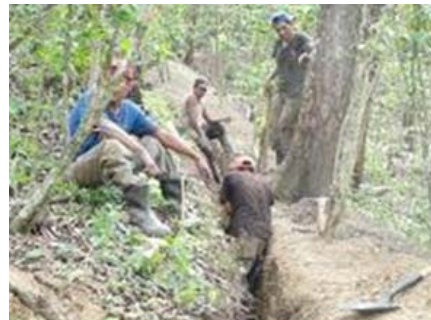
We installed two conduction lines to carry water from the springs to the tank. As per APLV norms, there are no tapstands or connections in this part of the system to guarantee the quantity of water reaching the tank.

**Conduction line trench**

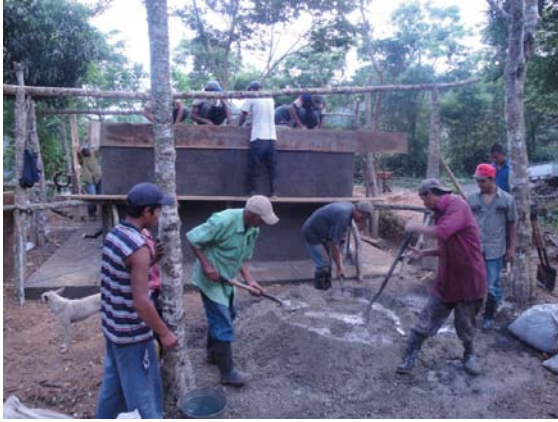
The tank is situated in one of the highest parts of the community. It has a volume of 13 cubic meters. It includes a bypass connection that can redirect water directly from the spring to the tapstands. This bypass permits cleaning and maintenance of the tank without interrupting the flow of water to the distribution system.

***Construction of the tank by the community***

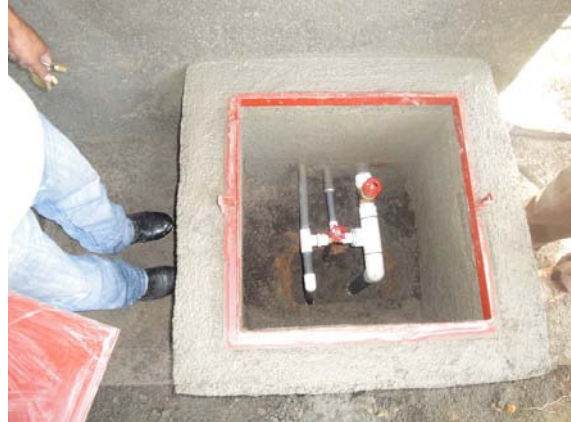
***Bypass connection of the storage tank***

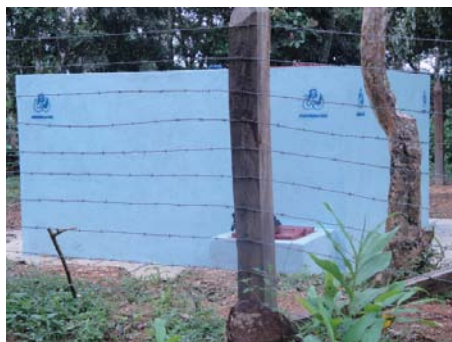
***Completed storage tank***

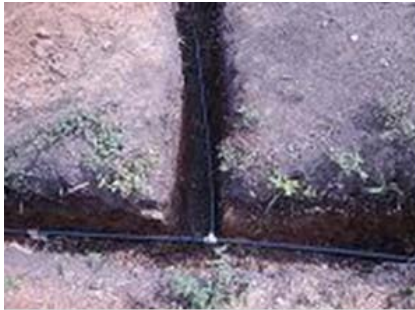
The distribution system carries the water from the tank to the household faucets. TO ensure that the system works well, careful hydraulic calculations were made so that each faucet receives sufficient flow and so the capacity of the system meets the needs of the community.

***Trench and pipe of the distribution system***

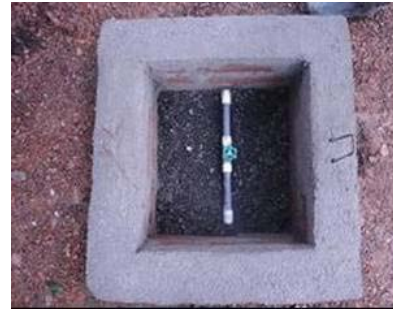
Gate valves were installed to enable dividing the system into sections. This is important to allow for repairs and maintenance of the system.

***Gate valve***

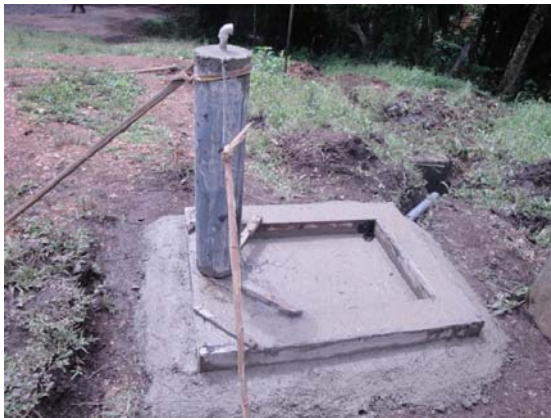
Each household tapstand includes a concrete pad and drain with a pipe that leads drainage water away from the tapstand. Faucets were installed at a height of 1 meter and were designed for a flow of 8-10 liters/minute.

***Final construction of a household tapstand, including drainage***

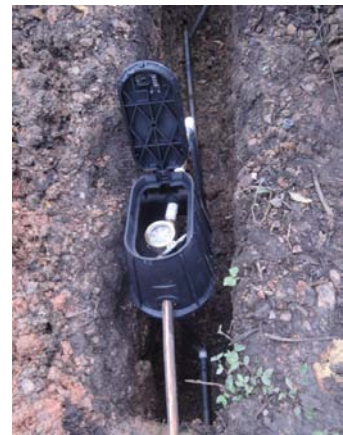
Meters were installed at each tapstand according to APLV norms. Meters help the community use water more conscientiously. Each household pays a monthly fee as detailed in section 2.2.7.2.

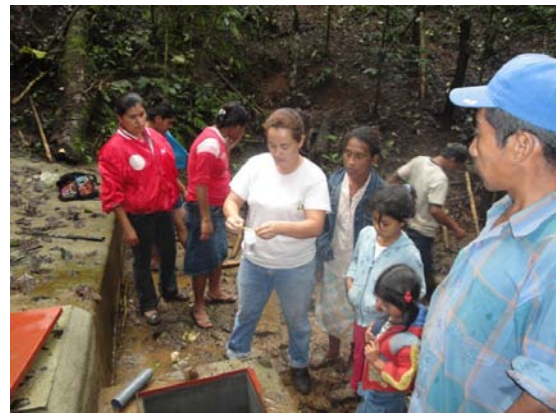
***APLV health educator demonstrating to the water committee how to test water quality***

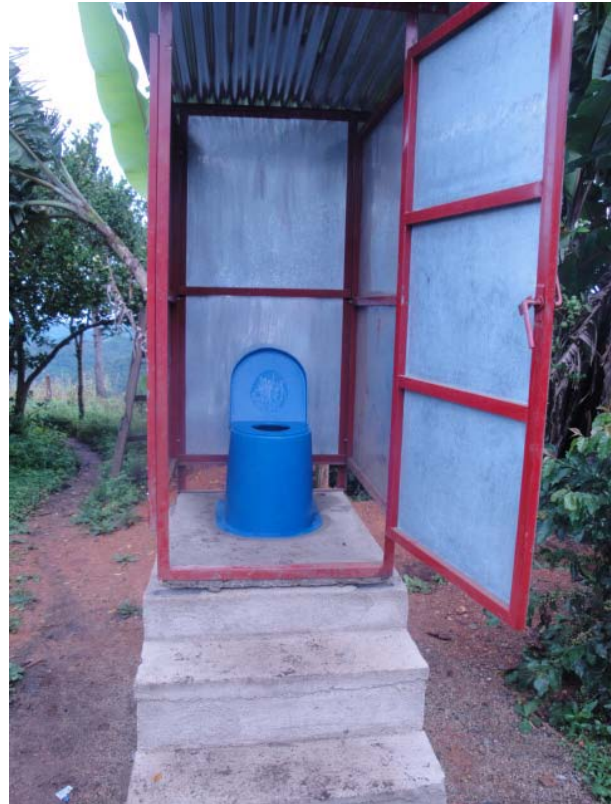
Latrines were elevated 1 meter and included an additional 1 meter deep foundation below the surface of the ground. They include a special seat that makes them safe and convenient for children.

*Letrina construida con taza para los niños*

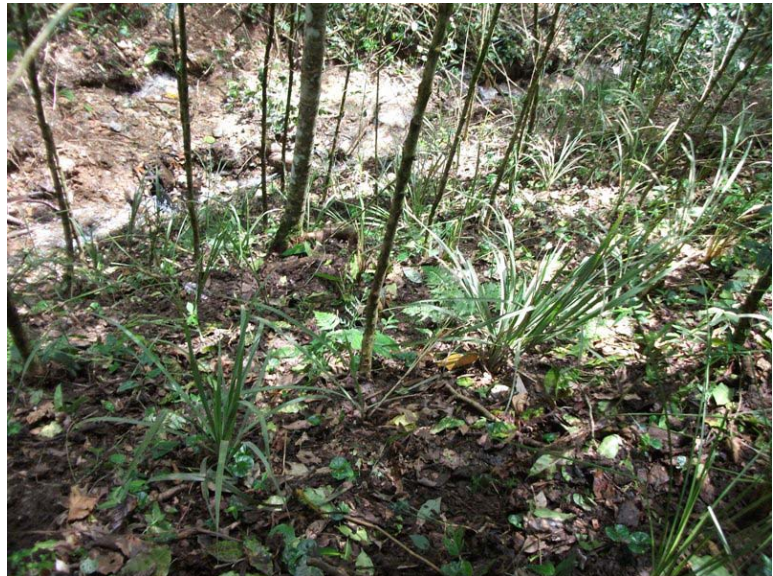
Consequently, the watershed is not in need of increased forest cover. However, there is a need to improve the protection and securing land in the vicinity of the second spring capture, thus allowing better water infiltration and avoiding the collapse of the bank.

***Planting grass in the area near the second spring***
