WELL REHABILITATION PROJECT REPORT: HONDURAS APRIL 2009

Patricia Patyrak, Sr. Grant Writer- Development

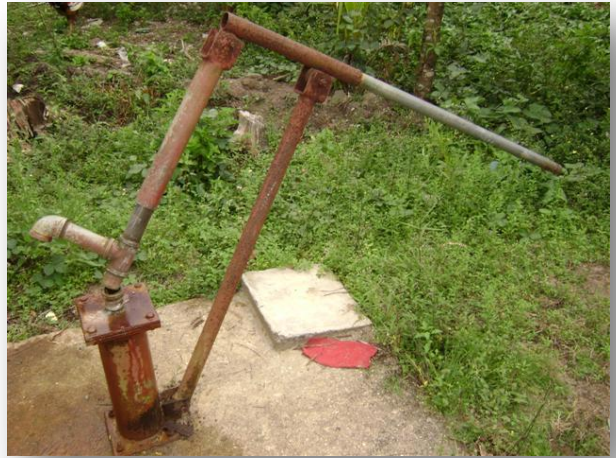
The pump and cylinder rusted

Since most of the pump parts were rusted out jeopardizing the quality of the water, the repair team took out the old pump, cleaned and flushed out the well (chlorinated the well, if needed), fixed the pump base and concrete pad and installed a new India Mark II hand pump. When the well rehabilitation was complete, the team gathered the community around to explain how to properly use the pump handle so that there is minimum wear and tear on it and also suggested that the community builds a fence around the well to keep the site protected from animals. All of the communities were very grateful to the donor and the LWI Honduras team for restoring clean, safe water to their community.

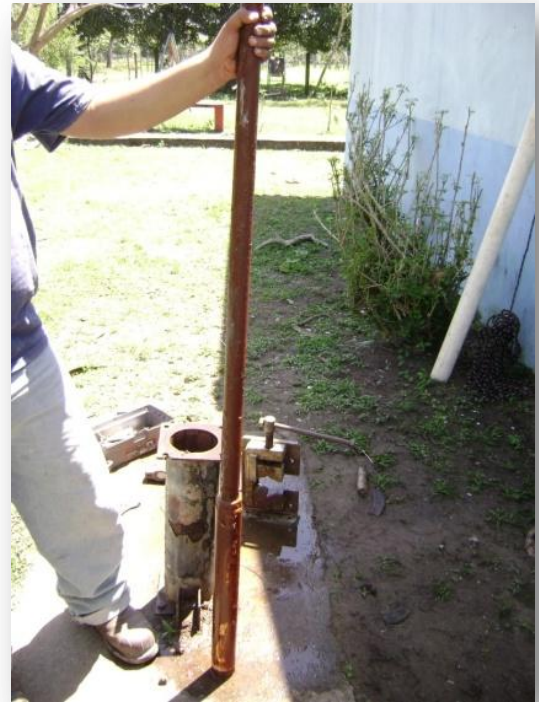
Most of the locations where the wells were repaired were in schools where the students and community relied on this source of water. At one location in Rosita, the LWI Honduras team surveyed the well and discovered that the cylinder pump had rusted out pretty bad and the water was starting to taste like iron. Also, there was a buildup of sediment in the screen. When the well broke, the people in the community had to resort to collecting water from a river or stream nearby or the hand dug well that they had once used before the new well was installed. This contaminated water was the source of their diarrhea and intestinal problems. The well was cleaned out, chlorinated and a new India Mark II hand pump was installed. The water regained its clarity and iron taste disappeared. After the well repair was complete, the students tested out the new pump and expressed to the team gratitude for fixing the well.

The cylinder pump and riser main are shown as being rusted.

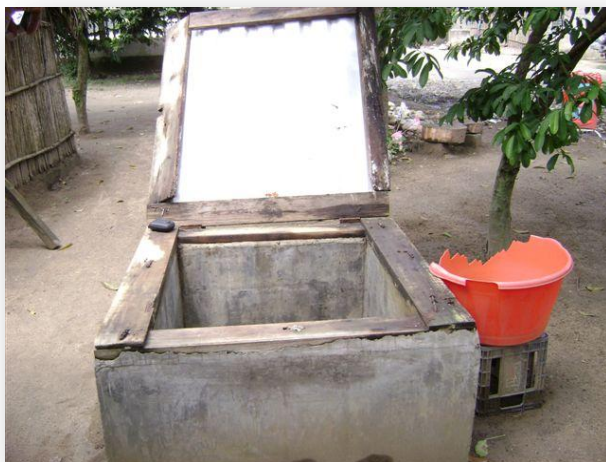
Hand dug well at school that students had to go back to using when the well broke.
