Community Water Supply and Sanitation Project Masicales, Honduras

Ann Campana Judge Foundation Project Report

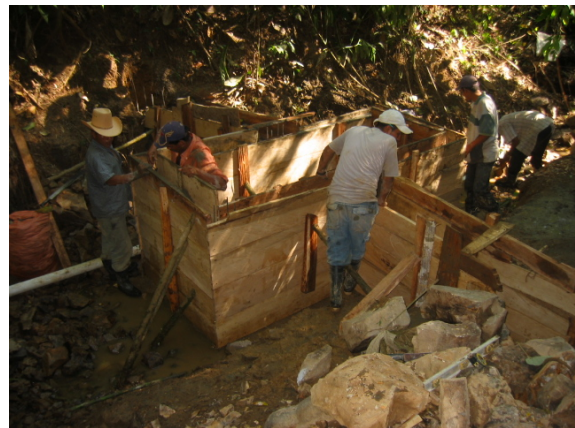
The water system operates by gravity flow. A small water-diversion dam was constructed on a stream about 0.9 miles up gradient of the town. The diverted water flows from the dam through a buried pipeline to a 5,000-gallon storage tank located on a

hill above the town. Granular chlorine is added as a water treatment from a hypochlorinator located on top of the main storage tank. The chlorinated water is piped from storage tank to a standpipe at each home through a buried distribution system.
